## ARCHAEOLOGICAL RECOVERY AT QUEBRADA DE LA VACA, CHALA, PERU

FRANCIS A. RIDDELL

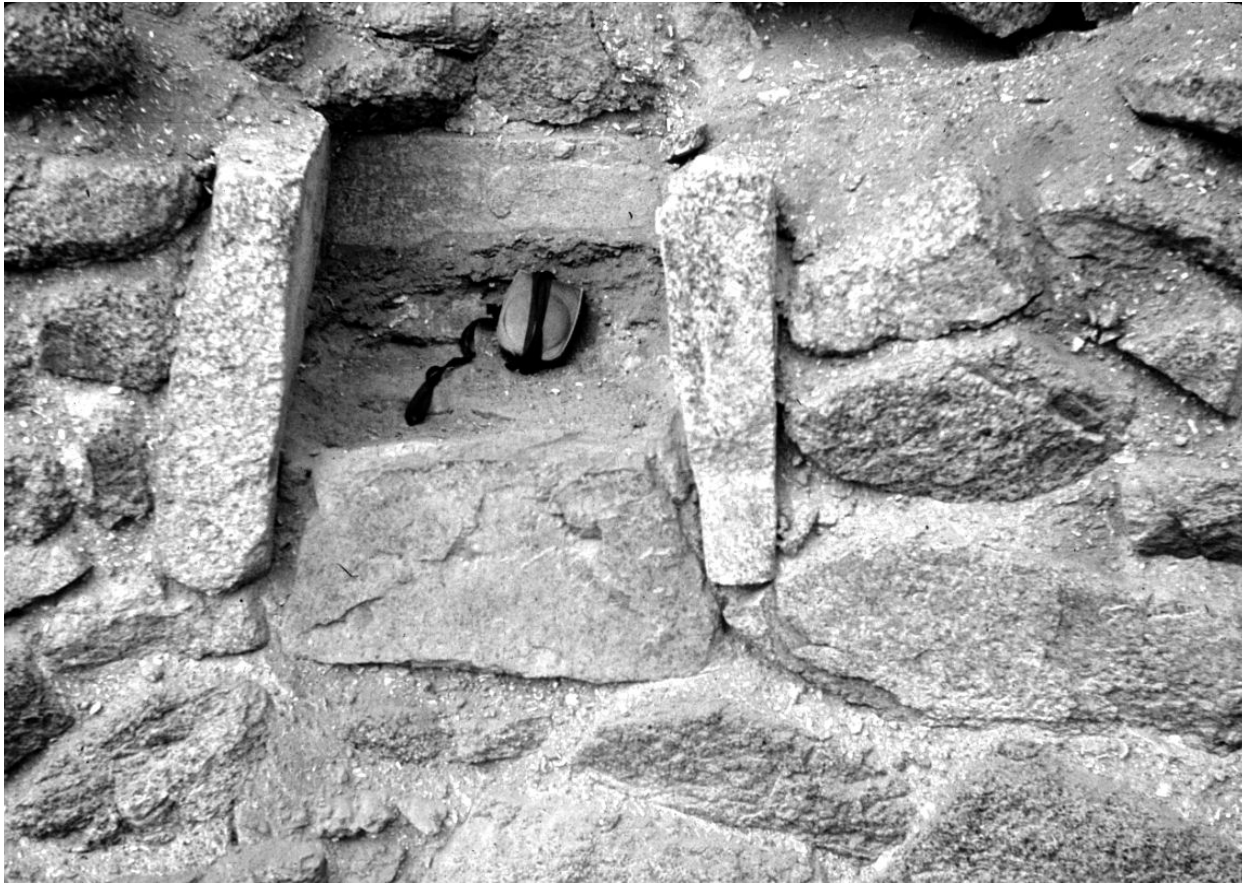
Figure 7. Trapezoidal niche at Quebrada de la Vaca (photograph by F. A. Riddell. 1954, courtesy of the California Institute for Peruvian Studies).

There are three niches in the west wall. The two northernmost niches are 70cm above the floor and the southernmost niche is 80cm above it. Such trapezoidal niches are common in these ruins and widespread in Inca architecture generally (Figure 7).

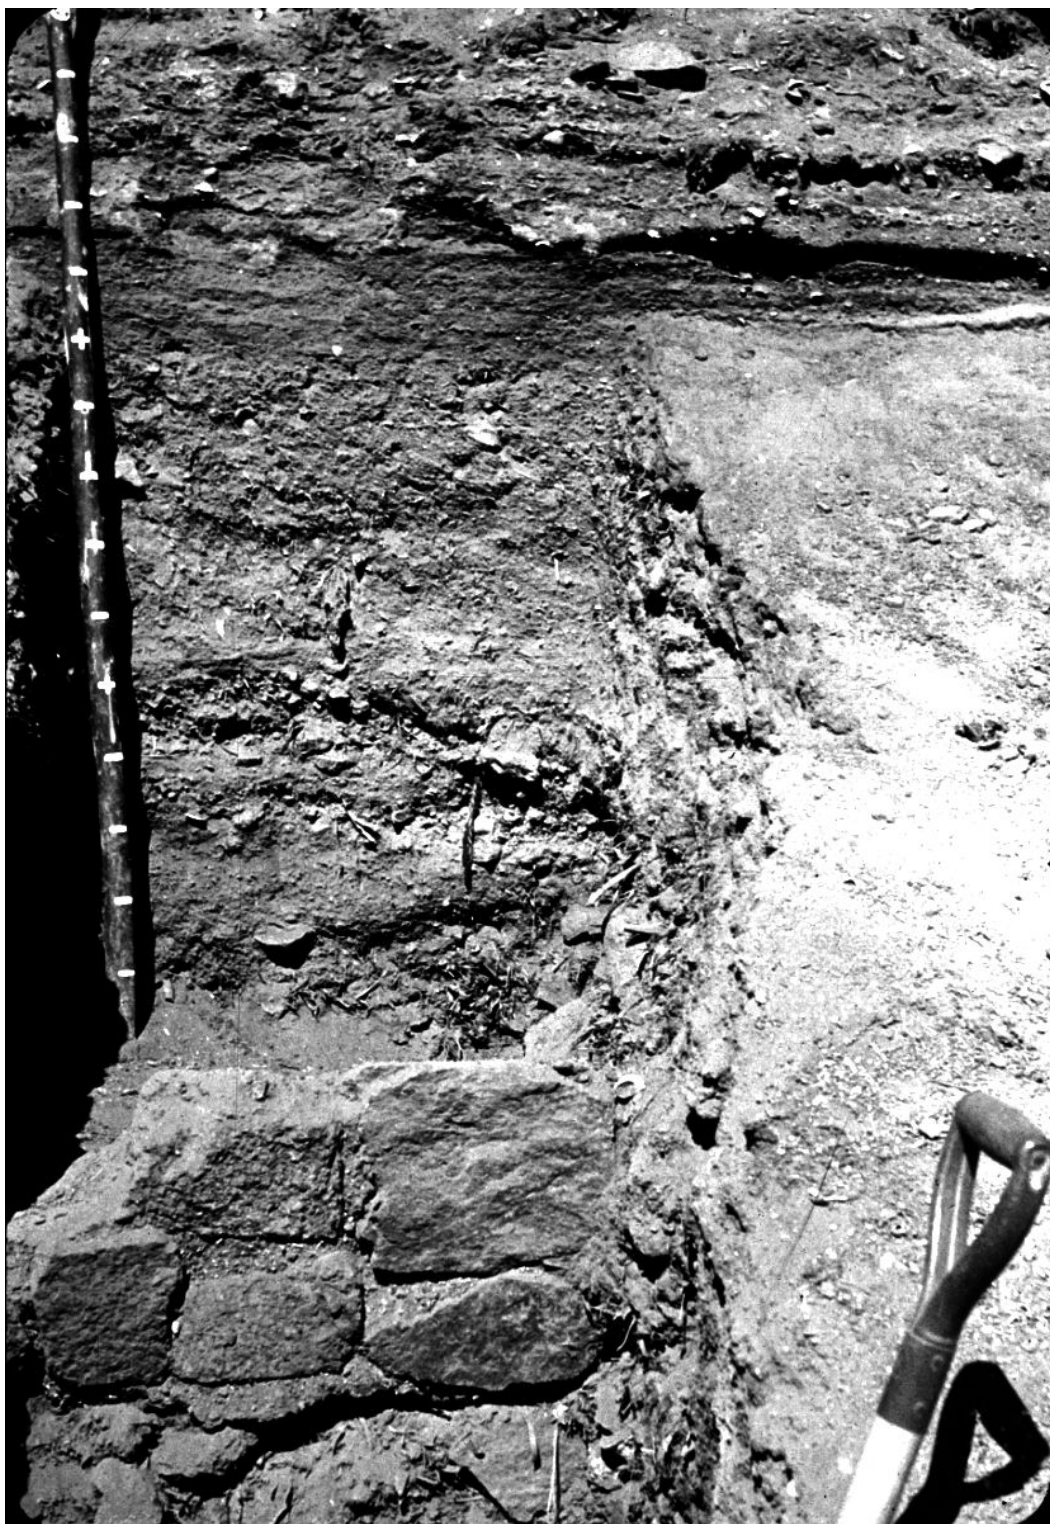
Figure 9. Test Trench 2, Quebrada de la Vaca. Note low retaining wall beneath midden (photograph by F. A. Riddell, 1954, courtesy of the California Institute for Peruvian Studies).

After proceeding for about 1m into the slope, we encountered the outside face of a retaining wall about .5m high, built in the same style as the rest of the ruins (Figure 9). Its interstices were filled with organic matter and other refuse. It had been built atop an earlier wall of angular, unmortared stones. We exposed the face of the wall from its top to below its base, a distance of about 40cm. The wall seems to have been built to retain midden and was buried by the disposal of garbage and subsequent downward drift of the midden from the slopes above it.

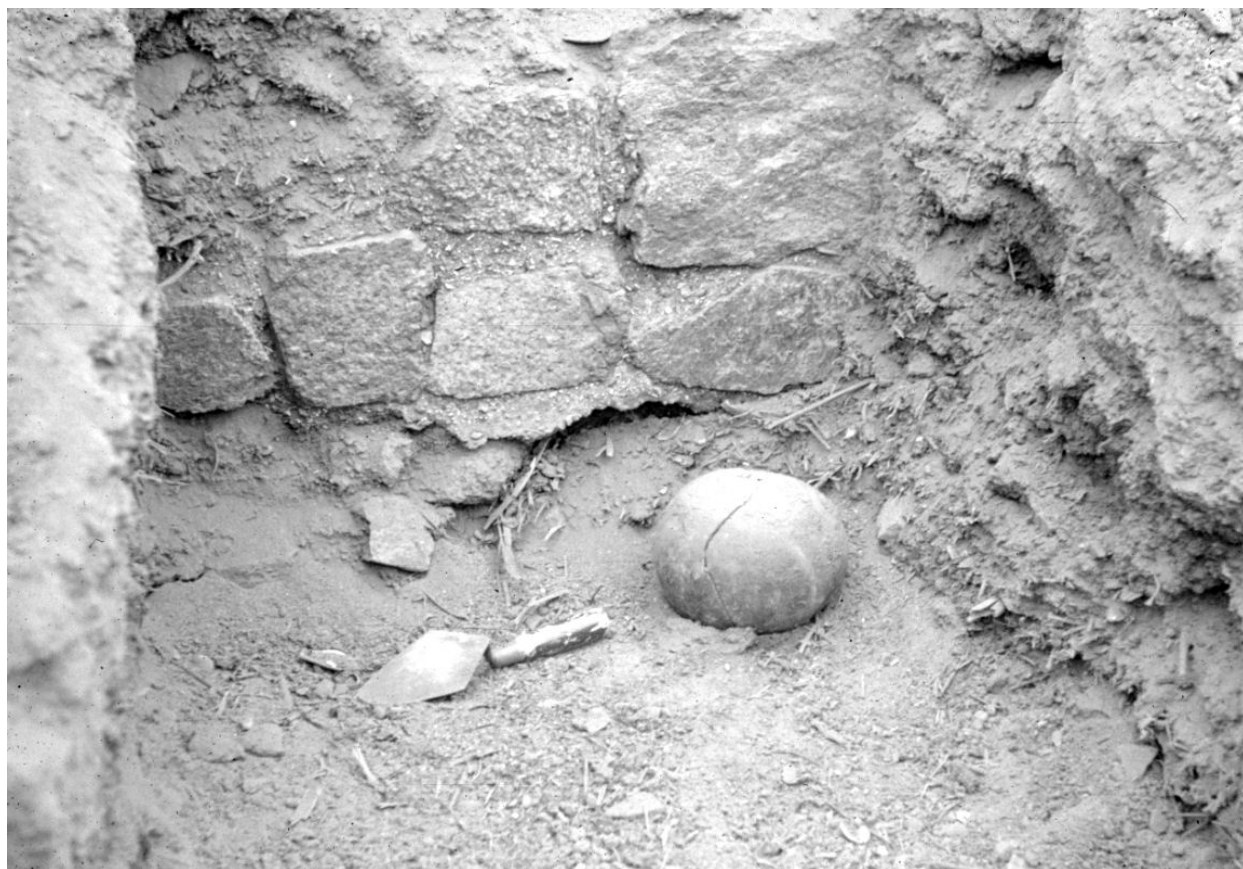
*Figure 10. Test trench 2, Quebrada de la Vaca. Gourd bowl. See Figures 9-12 (photograph by F. A. Riddell. 1954, courtesy of the California Institute for Peruvian Studies).*

Just below the base of the wall and 5cm out from its face we found a gourd bowl with a diameter of c. 20cm. It was resting in the mouth down position (Figure 10). The gourd contained a small, rectangular cloth bag made from an old blanket or similar cloth (Figure 11). The cloth was tied up with cord. The bag held fossilized sea urchin spines, a strand of human hair bound with cotton thread, tufts of human hair, three small, dark, water worn pebbles, and two fragments of greenstone, a copper ore. Beneath the bag was a section of cane split lengthwise so that a bag could be stuffed into the hollow cane (Figure 12). The pieces of cane had been re-fitted together and bound with a string of human hair. We sent these associated artifacts to the Museo Regional de Ica with the rest of the Quebrada de la Vaca collections (Appendix 1). Investigations in 1990 provided the details given here.

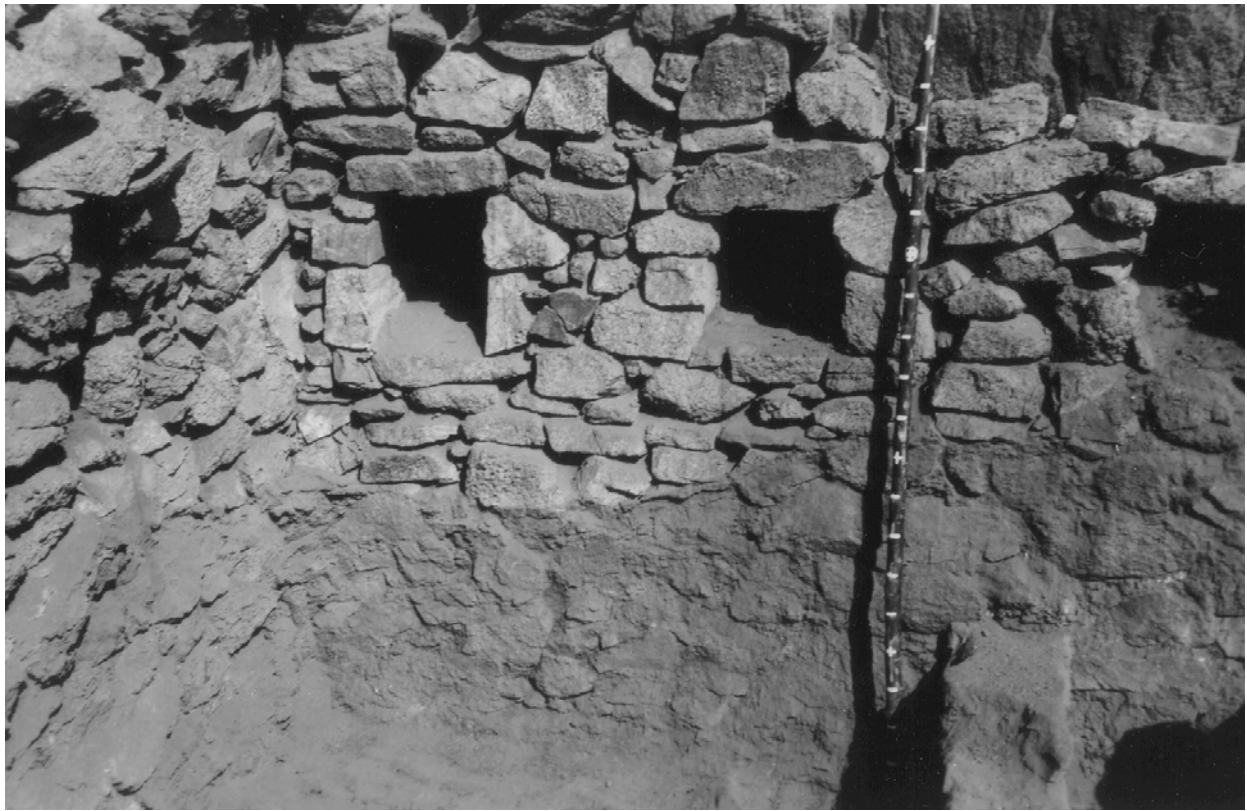
*Figure 18. Interior of Tomb 2 (Burial House 2) after excavation. Note fill line on walls (photograph by F. A. Riddell, 1954, courtesy of the California Institute for Peruvian Studies).*

We selected Tomb 2 (Figures 17, 18) to excavate. It was also built of granite and still in very good condition, even though it had probably been looted by the Spanish when they first came to the region. All the mummy bundles of Tomb 2, except those of infants, had been ripped open and all valuables had been removed by looters. However, during the course of the slow disintegration of the tomb, fine silt, soil, and sand from the roof sifted onto the mummy bundles before the heavy stone beams fell on top of the remains. I began excavation by removing the numerous fallen roof and wall stones and the 15 to 30cm layer of silt, soil, and sand. At this point I came upon masses of textiles. Protected by the silt, soil, and sand layer, the bones were in an excellent state of preservation, and not one skull was broken by the collapsed roof stones.

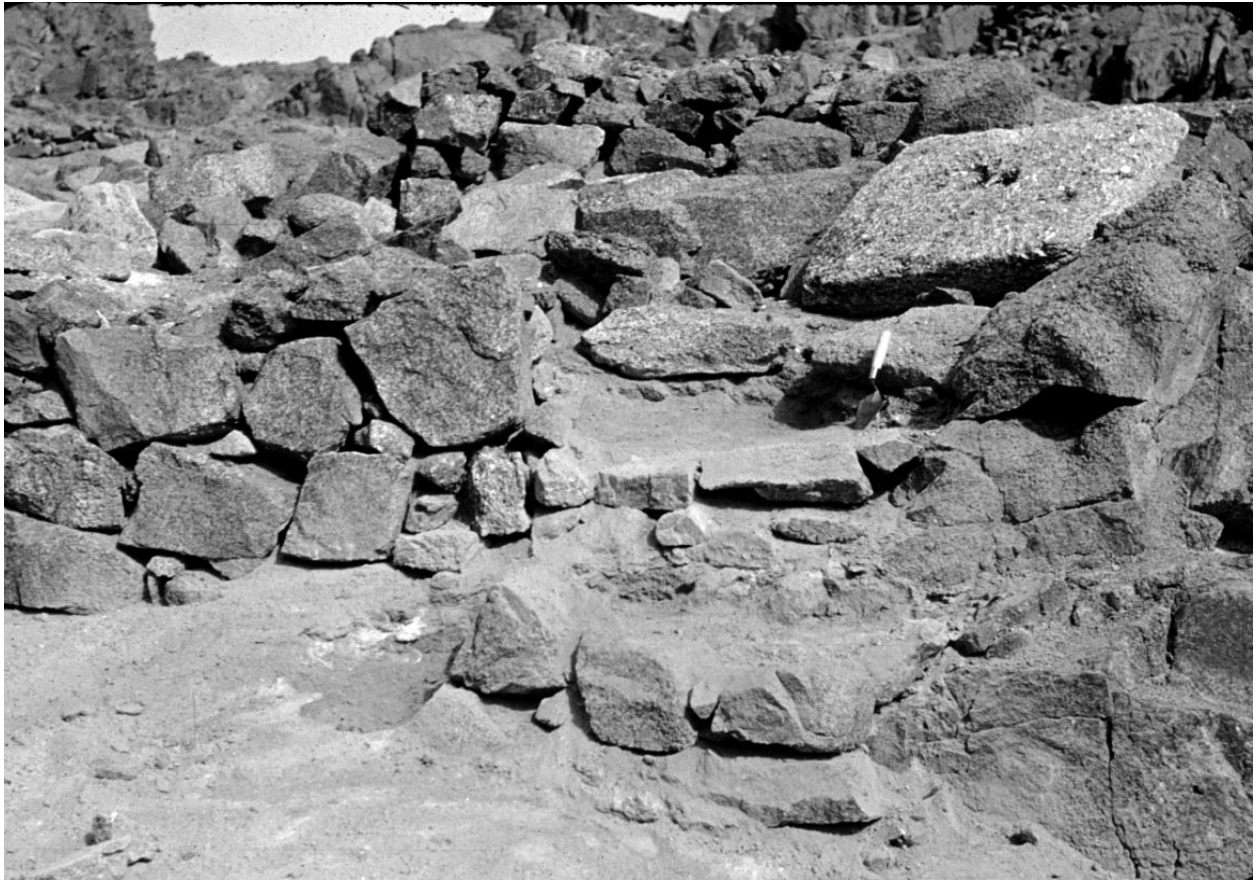
Figure 19. Stairway, Tomb 3 (Burial House 3), Quebrada de la Vaca West (photograph by F. A. Riddell, 1954, courtesy of the California Institute for Peruvian Studies).
