# RECONSTRUCTING THE GREAT HALL AT INKALLACTA

Vincent R. Lee, Architect  
*Institute of Andean Studies*

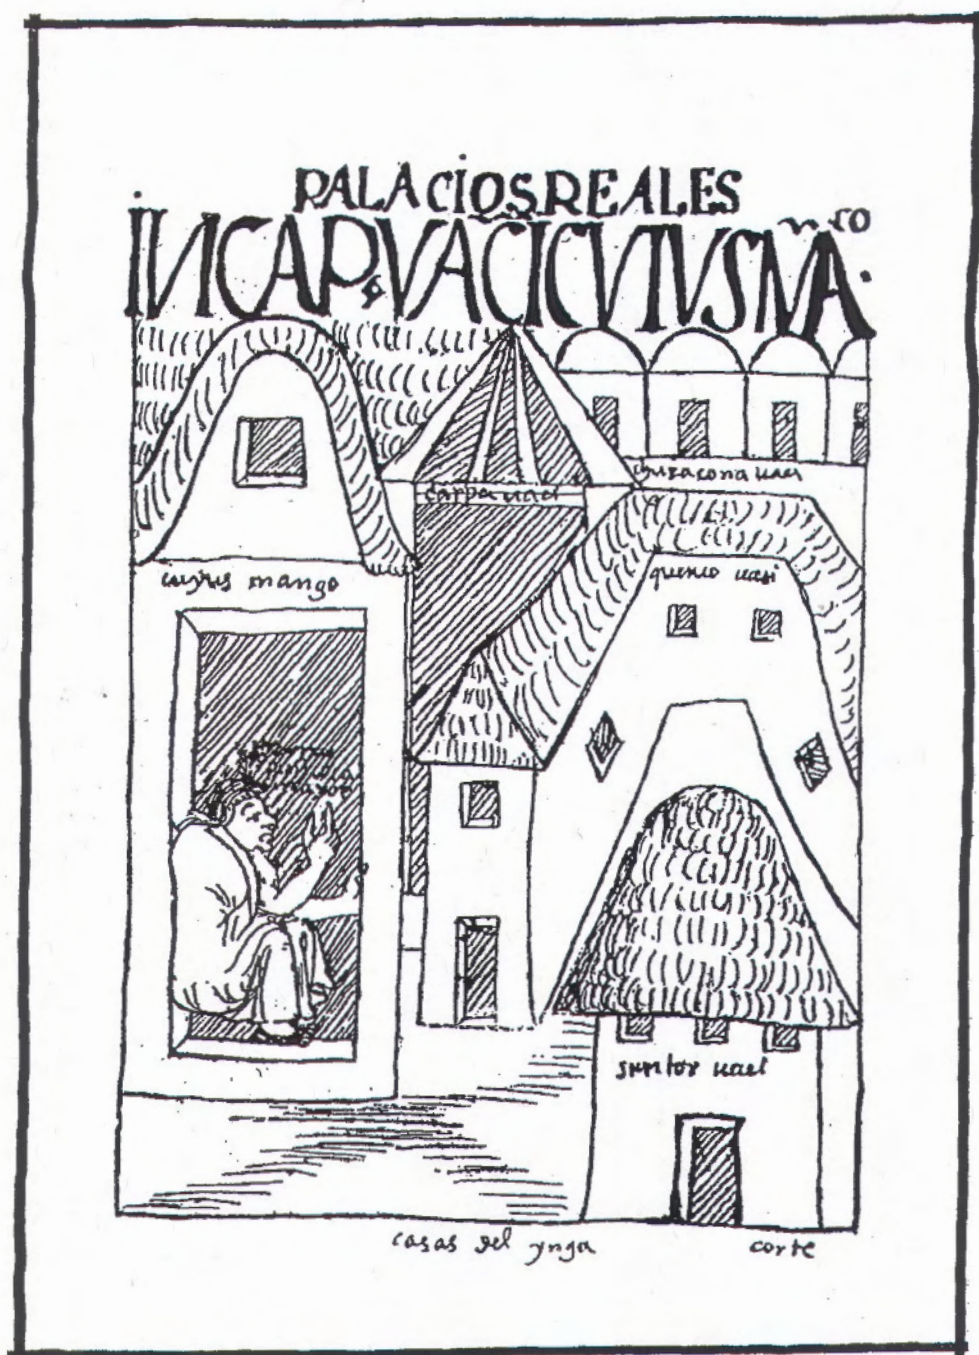
**Figure 3.** Royal palace at Cuyusmango in Cusco, after Guaman Poma de Ayala (1936 [1615]: 329 [331]).

[1609]:321). The drawings of Guaman Poma de Ayala (1936 [1615]) show various building types, but structural details are almost entirely lacking. His view of the royal palace of Cuyusmango in Cuzco (Figure 3) suggests only that the roof of that hall was rounded over the ridge, rather than rising to a sharp peak, an important point to which we will return later.

Similar to the "Dutch" or gambrel barn roofs common in rural America, the system proposed here not only resembles the profile of the Cuyusmango recorded by Guaman Poma (Figure 3), but would have been a good design on several counts. The steep pitch at the eaves reduces thrust onto the tops of the eave walls and creates headroom for the outer-most gable openings, while the lower pitch in the center allows for lower gable walls and eliminates unnecessary interior volume, framing materials and thatch. Even so, 12 and 15 m (40-50 ft) high posts would have been required in the inner rows, although they might have been spliced from shorter members the way tall, wooden ship's masts were a century ago. In any case, lateral bracing would have been needed to prevent failure by buckling, especially at the splices, if any. Again, the masonry suggests how this might have been accomplished.

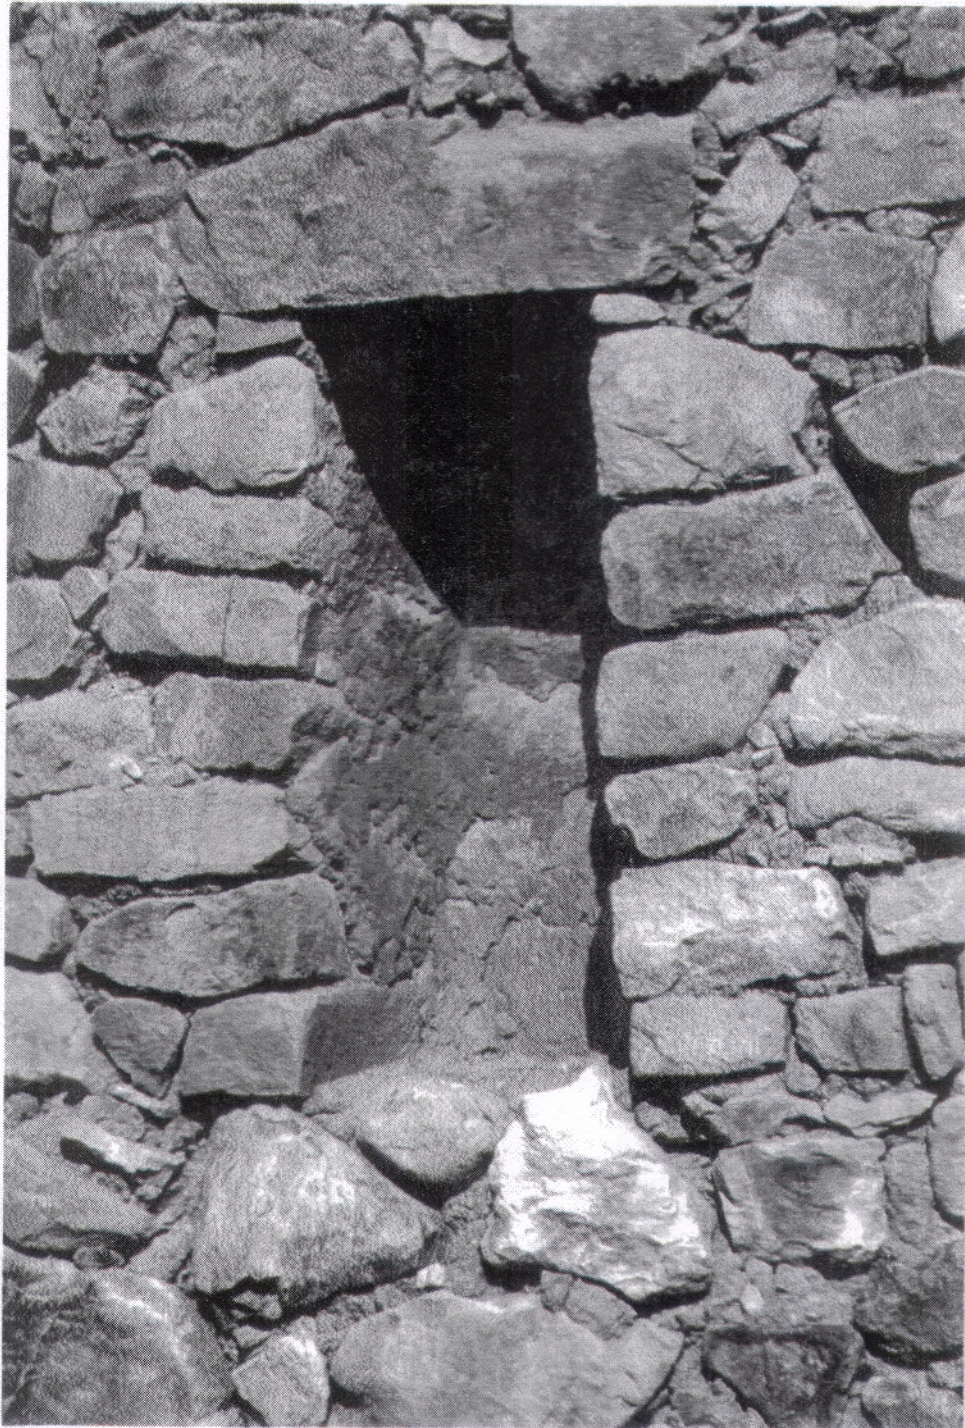
**Figure 8.** Plastered niche in Great Hall at Inkallacta.

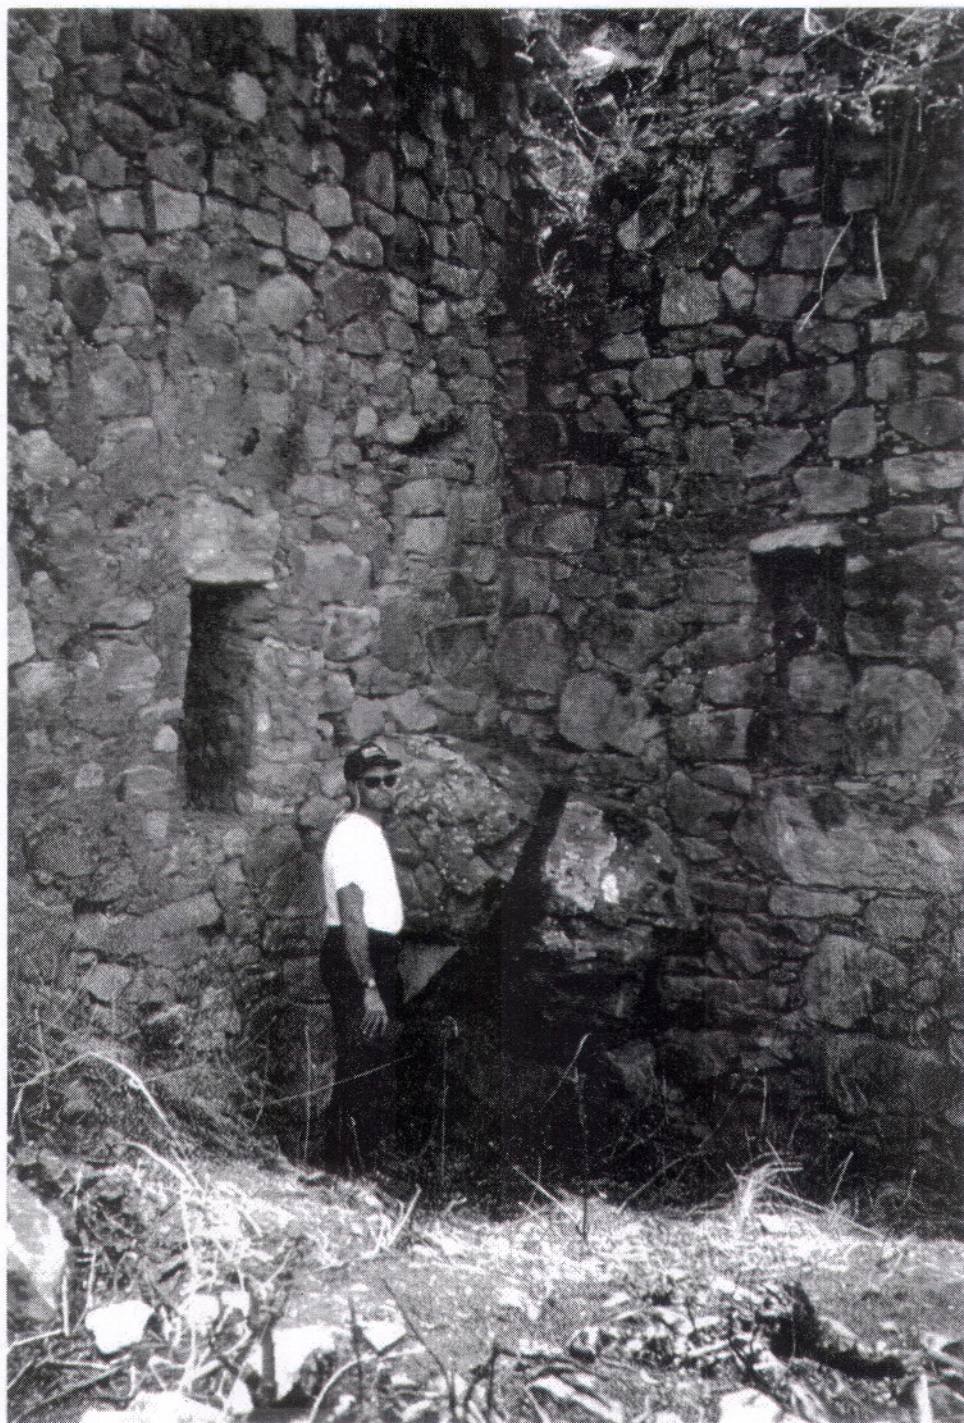
**Figure 9.** Plastered northwest corner in Great Hall at Inkallacta.

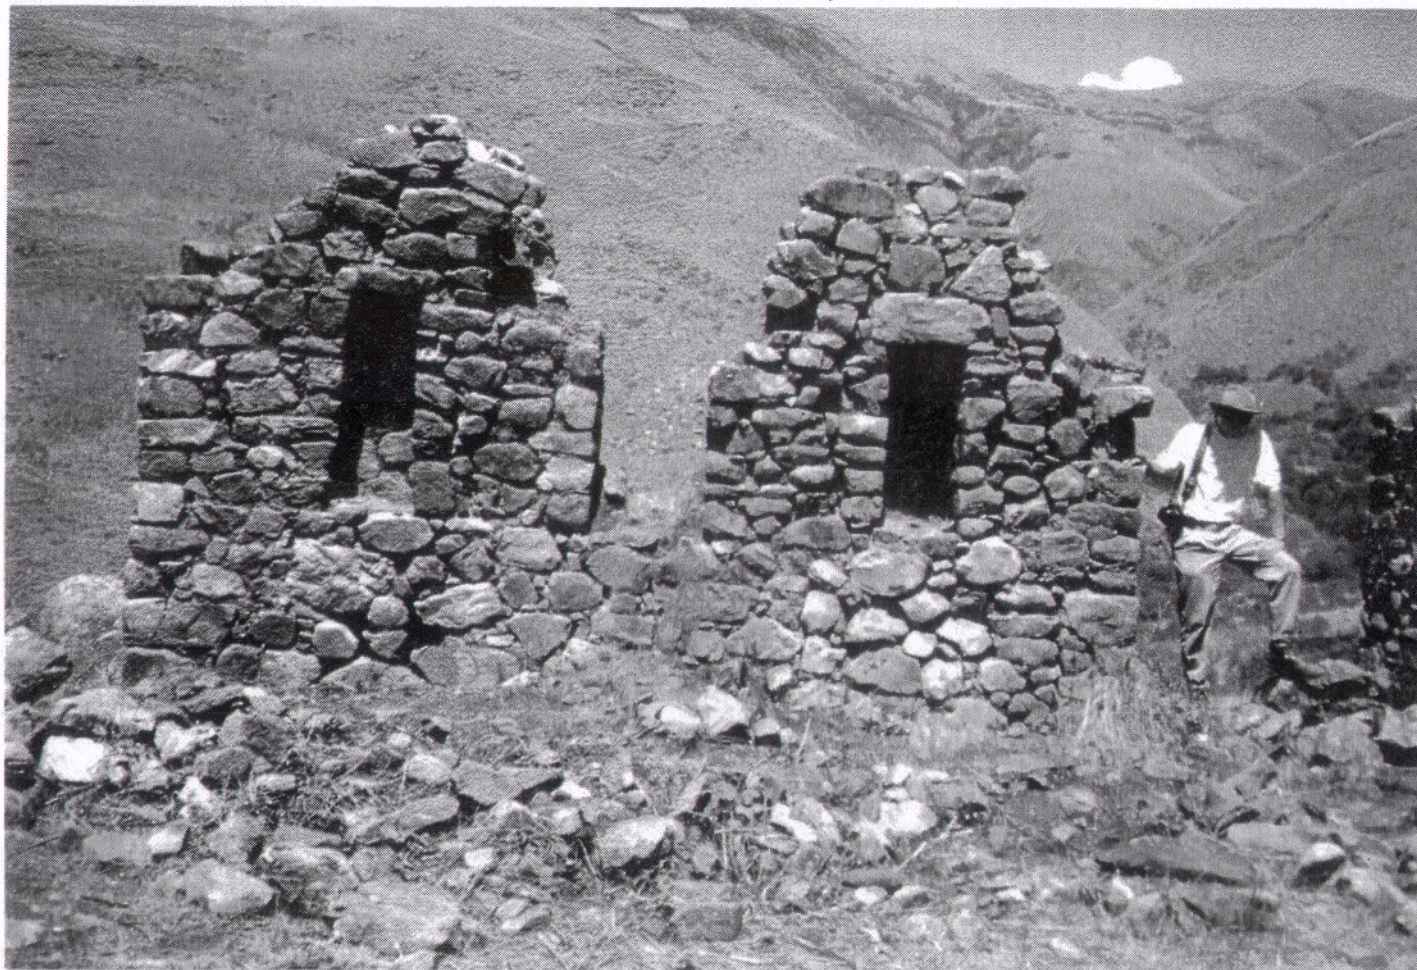
**Figure 11.** Damage to the south wall of Great Hall, Inkallacta.

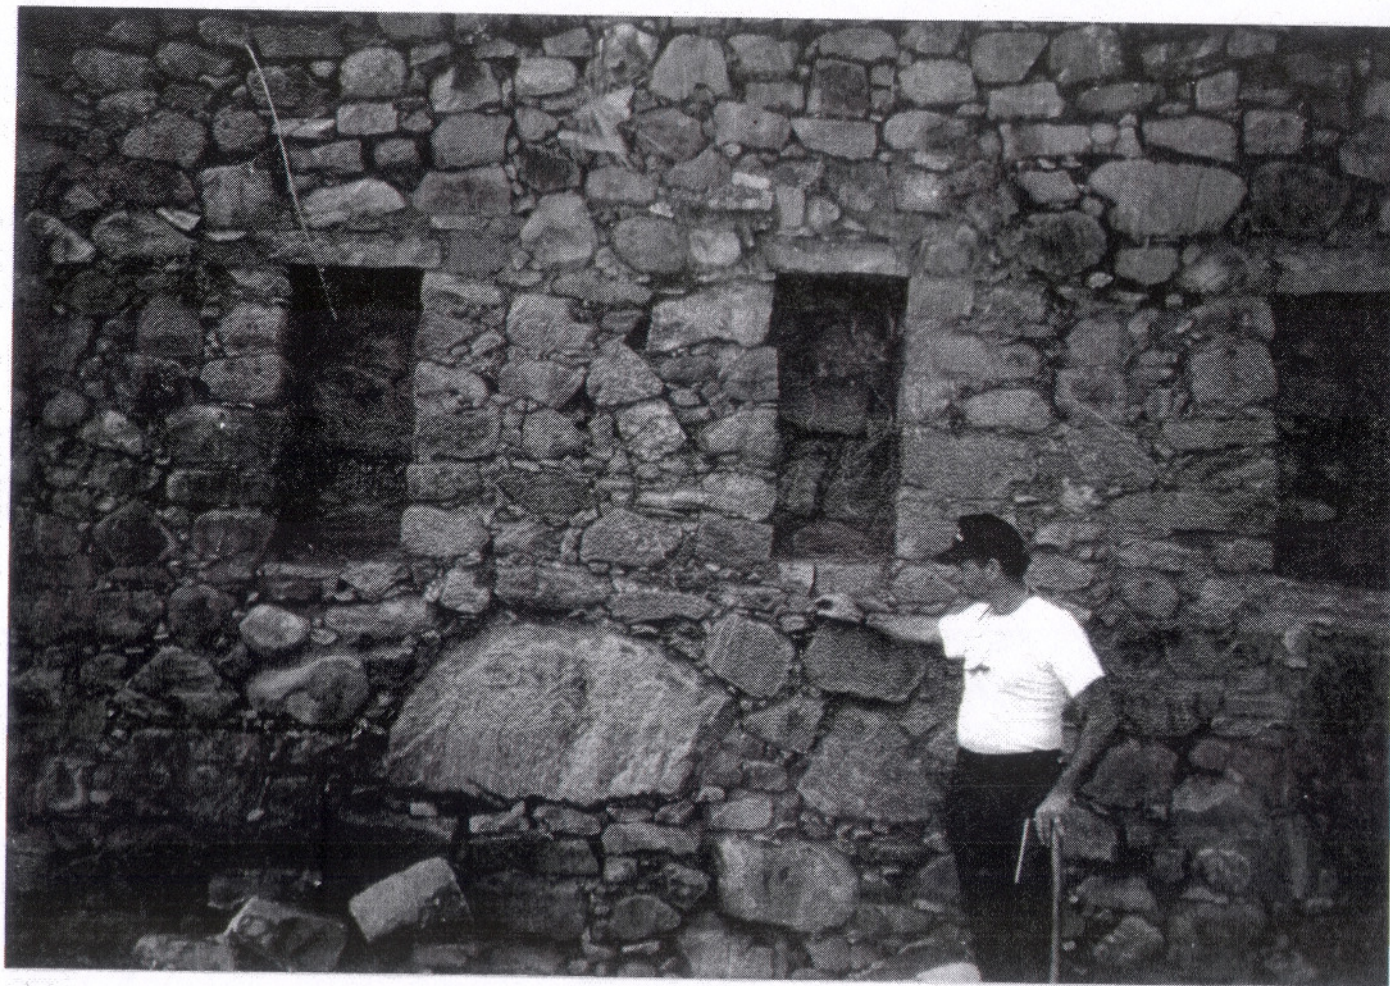
**Figure 12.** Niches in the north wall of the Great Hall at Inkallacta.

Except on the south, all the walls retain (or retained, at the fallen west end) some amount of grade. Behind the north wall, it varies from about 4 m (13 ft) at the northeast corner to 3 m (10 ft) at the northwest end. Down the outside of the gable ends, these depths decrease to a bit more than 2 m (7 ft) at the southeast corner and zero at the southwest. All these walls would have been strengthened by being thicker at their bases than at their tops, yet none shows evidence of battering. Instead, the heights above floor level of the many interior niches vary approximately in proportion to the depth of retained grade behind the walls. The result is that the northern niches seem inconveniently high -- at or above eye-level -- and those near the south corners are less than half a meter above the floor (Figures 7, 9). Also, the pattern of the stonework sometimes shows a faint line in the joints connecting the base of one niche to that of those adjacent to it (Figure 12).

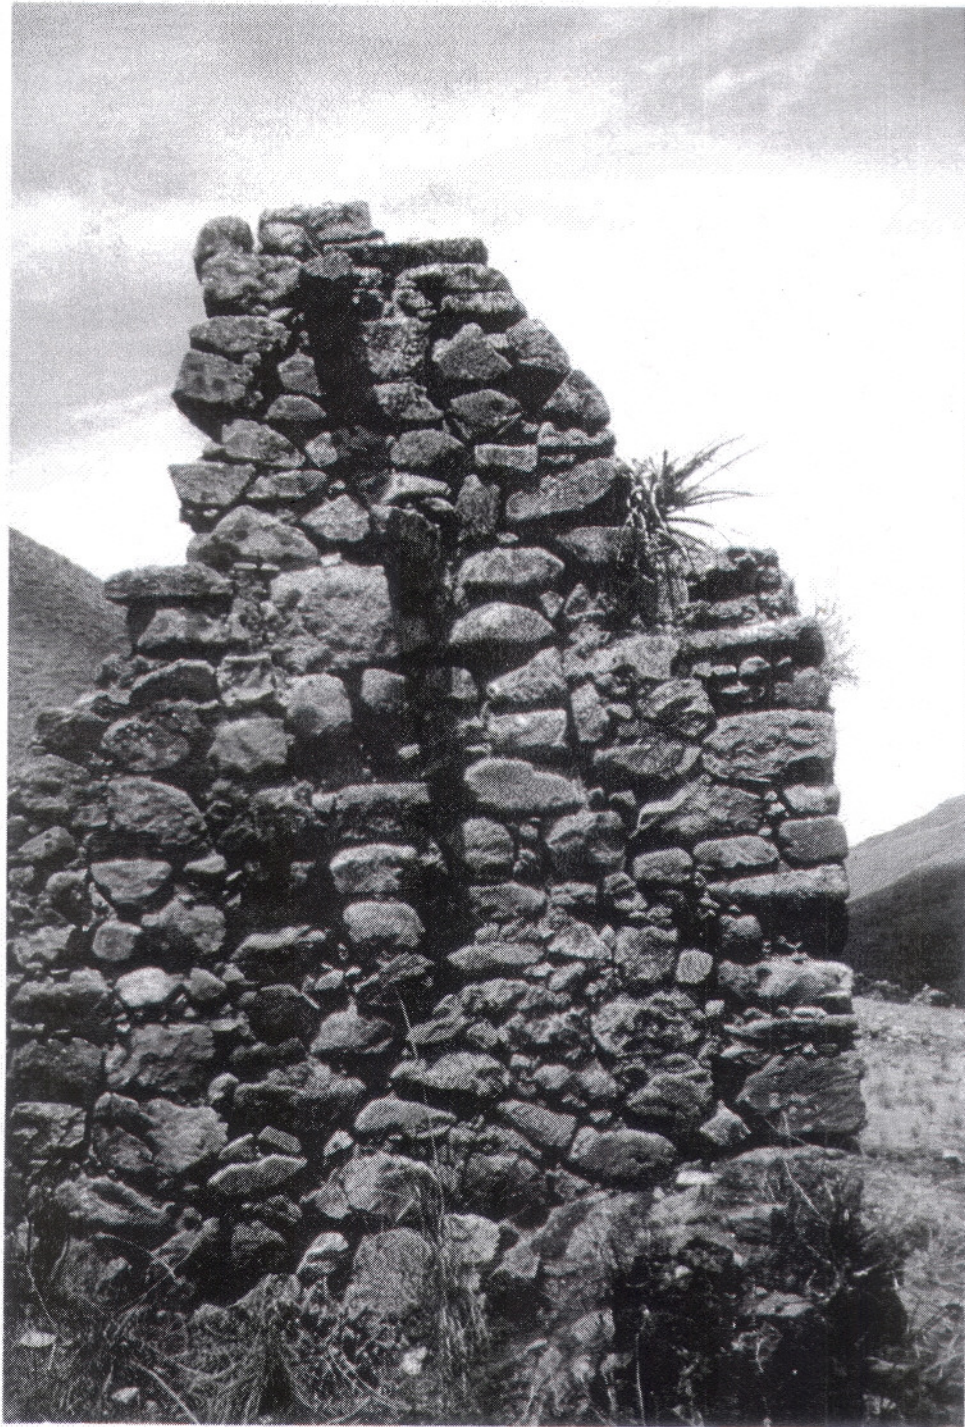
**Figure 16.** Southwest gable corner, Great Hall, Inkallacta.

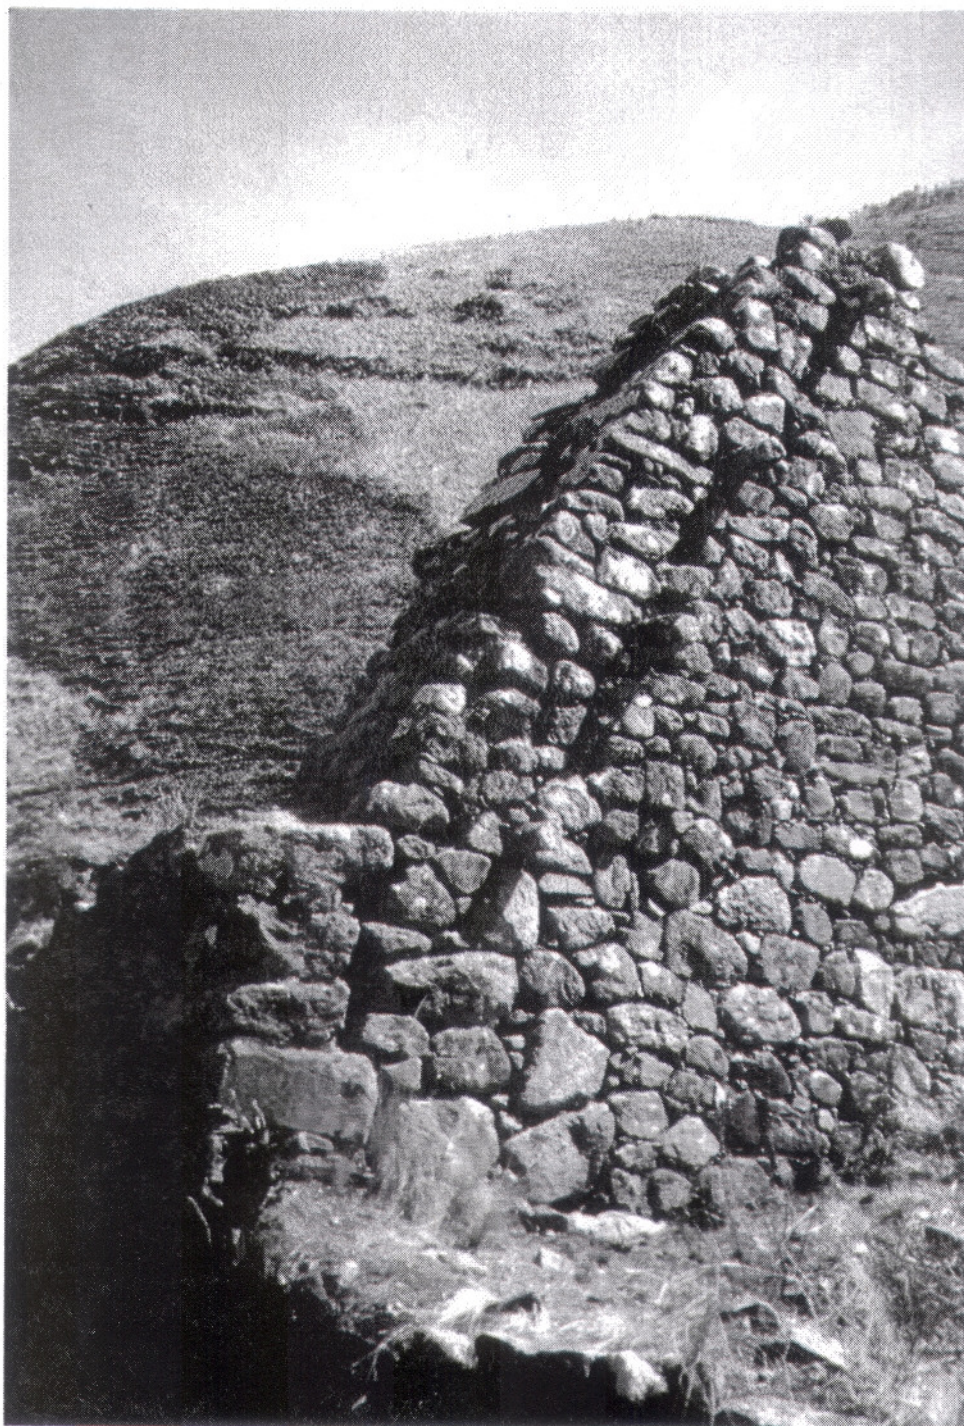
**Figure 17.** Southeast gable corner, Great Hall, Inkallacta.

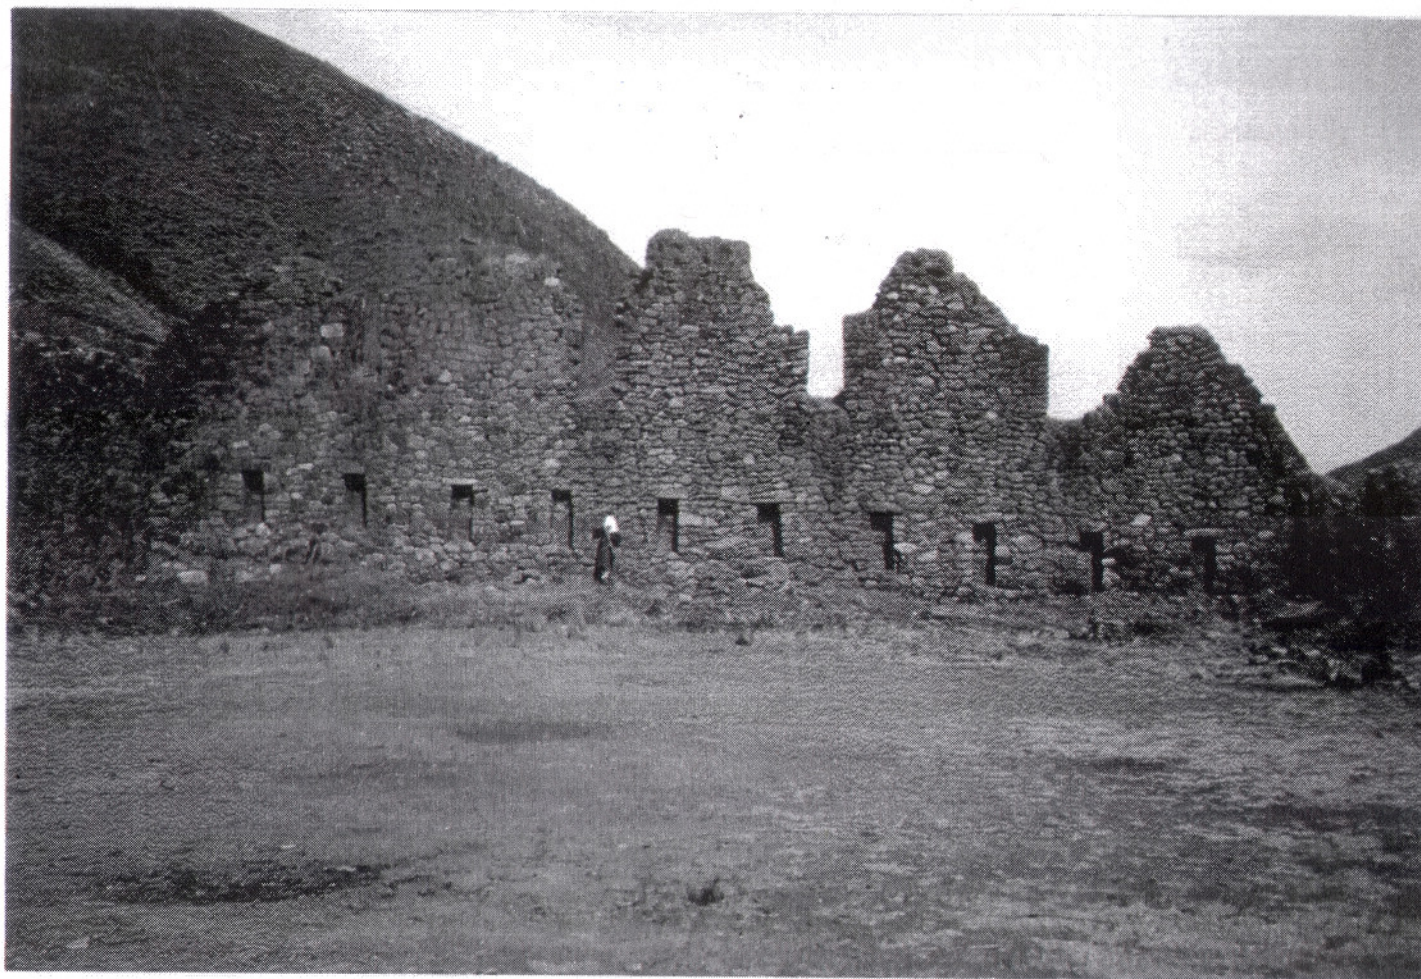
**Figure 19.** East gable end of Great Hall at Inkallacta.
